CITY OF BALTIMORE WET WEATHER CONSENT DECREE SMOKE AND DYED WATER TESTING FORM		Page 1 of 8
Sewershed: Low Level Subsewershed: 44	Company: REI/DRAYCO	Date: 08/25/2008
Test Type: Smoke	Ground Condition: Dry: <input checked="" type="checkbox"/> Damp: <input type="checkbox"/> Wet: <input type="checkbox"/>	Supervisor: E.R. Crew: 03
Manhole ID: S17K__040MH	Test ID: 1029-552	Notifications Made: <input checked="" type="checkbox"/> X Residents, Fire, 311
Field Sketch: (Show all manholes with numbers, blower placement location, sandbag or isolation locations, street names, building addresses and locations, defect locations and photograph numbers)

CITY OF BALTIMORE
SMOKE TESTING OBSERVATION SUMMARY
LOW LEVEL SEWERSHED
BALTIMORE CITY PROJECT 1029
REI/DRAYCO

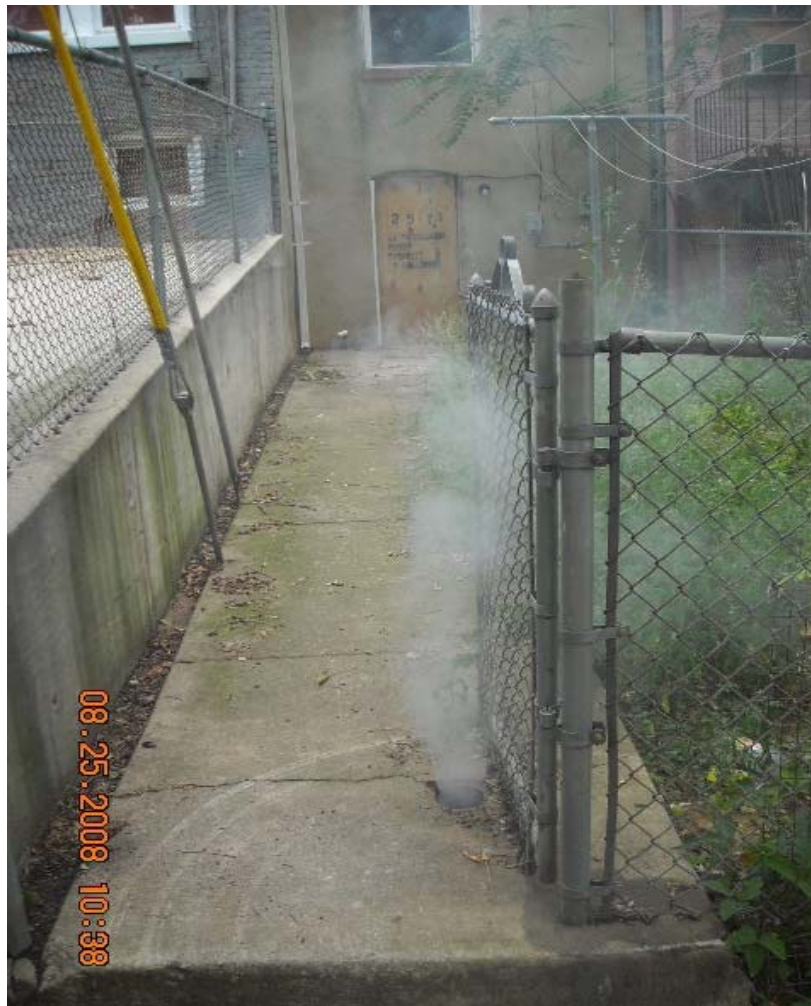
Photograph No: OB01-01
Filename: 1029-552_OB01-01.jpg

Unique Test ID: 552	Date: 08/25/2008	Basin: LL - 44	Manhole ID: S17K__040MH
Defect No: OB01	Supervisor: E.R.	Crew: 03	Dye Test Recommended: N
Location: 2511 MCHENRY ST.			
Source Type: 03 Cleanout		Sector: 02 Private	
Location: 05 Sidewalk		Severity: 03 Moderate	Drainage Area: 2
Comments: SMOKE COMING FROM BELOW GRADE CLEANOUT ON SIDEWALK.

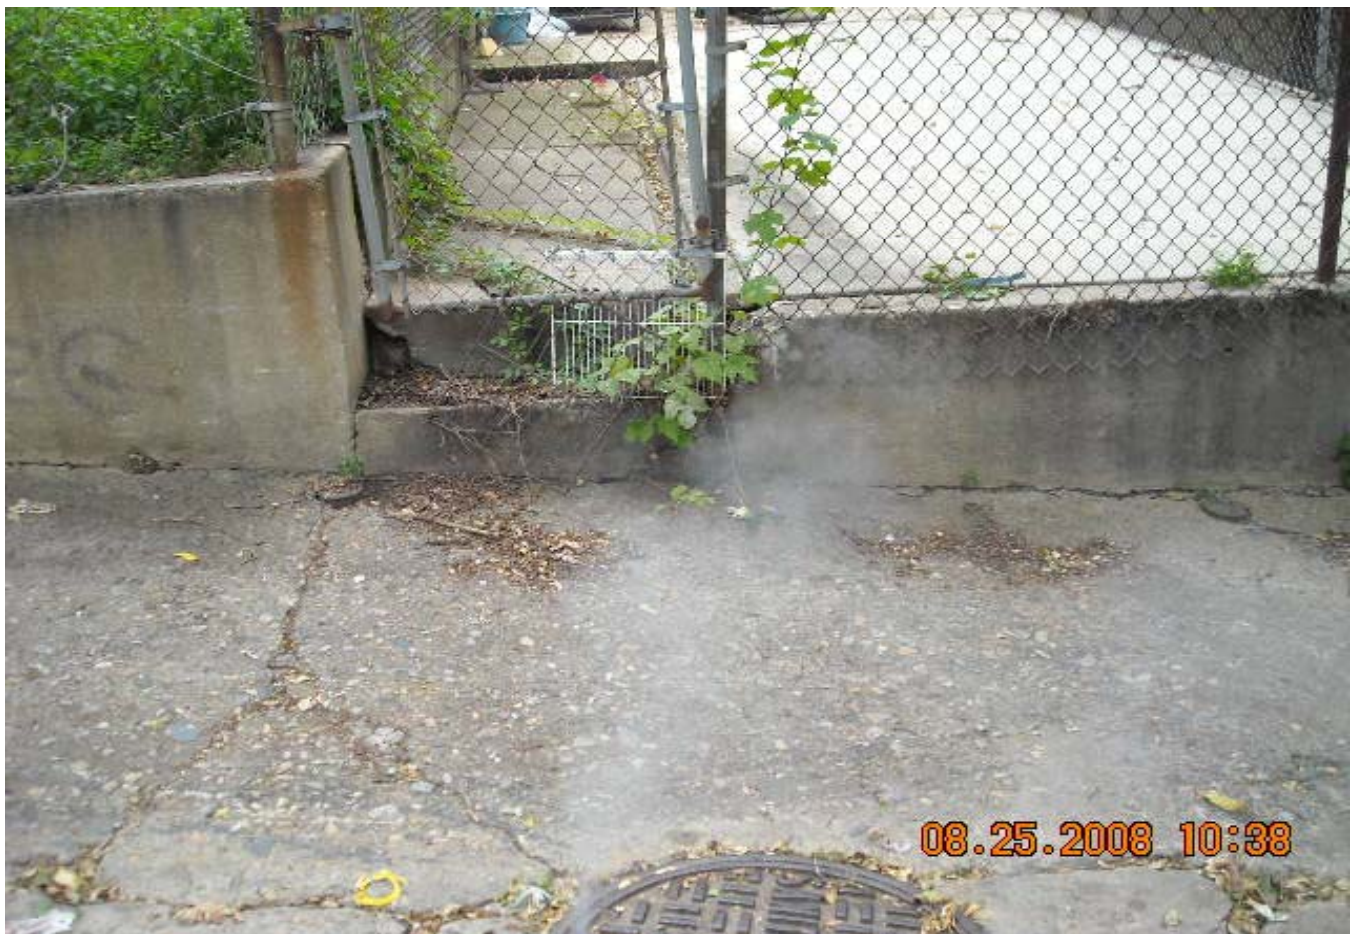
Photograph No: OB02-01
Filename: 1029-552_OB02-01.jpg

Unique Test ID: 552	Date: 08/25/2008	Basin: LL - 44	Manhole ID: S17K__040MH
Defect No: OB02	Supervisor: E.R.	Crew: 03	Dye Test Recommended: N
Location: 2513 MCHENRY ST.			
Source Type: 02 Service Line		Sector: 02 Private	
Location: 06 Curb		Severity: 03 Moderate	
		Drainage Area: 20	
Comments: SMOKE COMING FROM BELOW CONCRETE SLAB AROUND STEPS AND GATE.

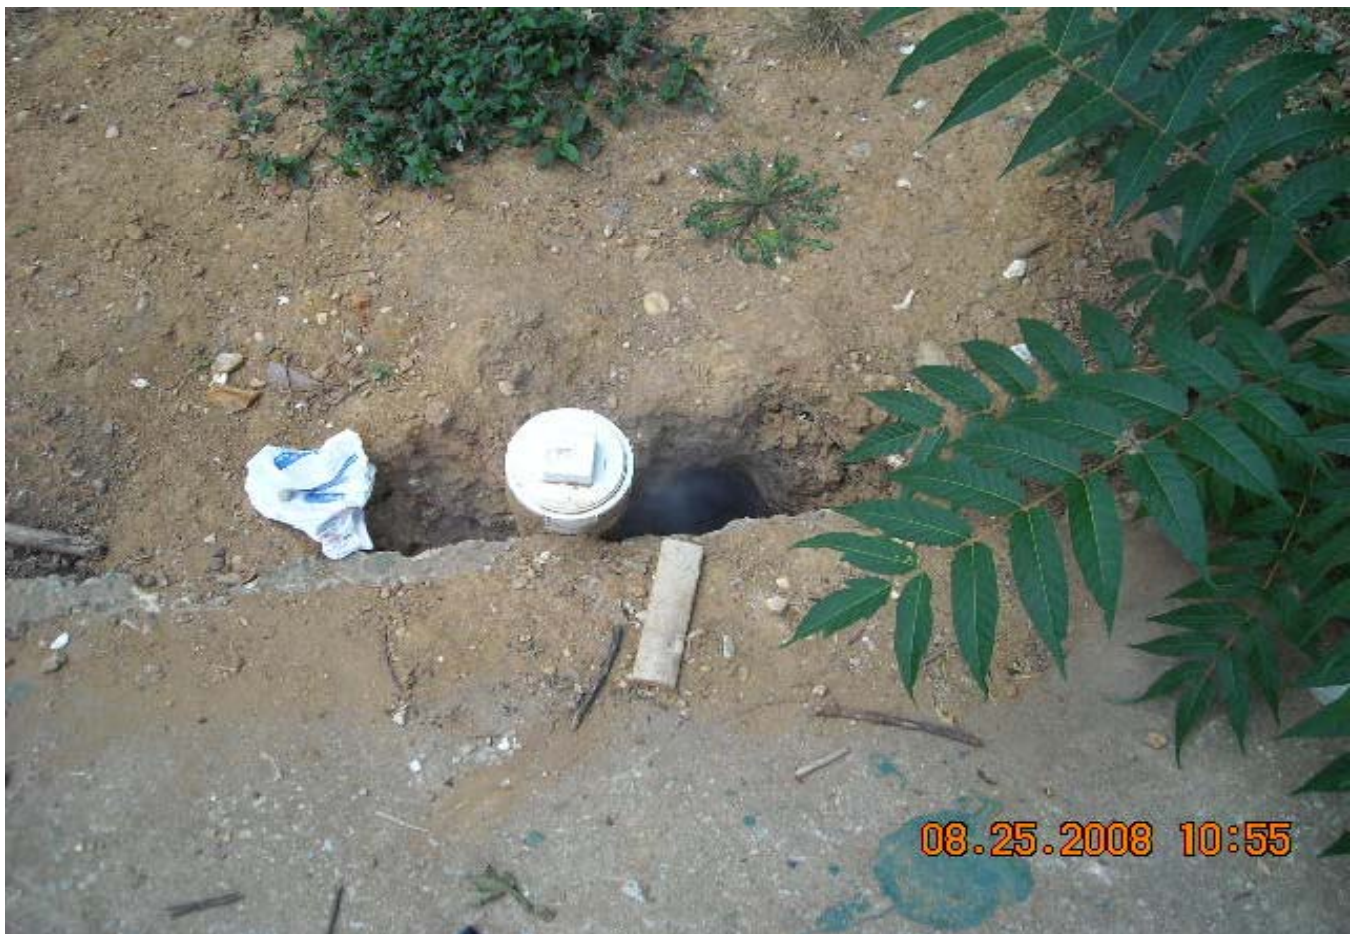
Photograph No: OB03-01
Filename: 1029-552_OB03-01.jpg

Unique Test ID: 552	Date: 08/25/2008	Basin: LL - 44	Manhole ID: S17K__040MH
Defect No: OB03	Supervisor: E.R.	Crew: 03	Dye Test Recommended: N
Location: 2538 FREDERICK RD.			
Source Type: 02 Service Line		Sector: 02 Private	
Location: 08 Yard - Back		Severity: 03 Moderate	Drainage Area: 10
Comments: SMOKE COMING FROM BELOW GRADE HOLES AROUND CLEANOUT IN BACKYARD.

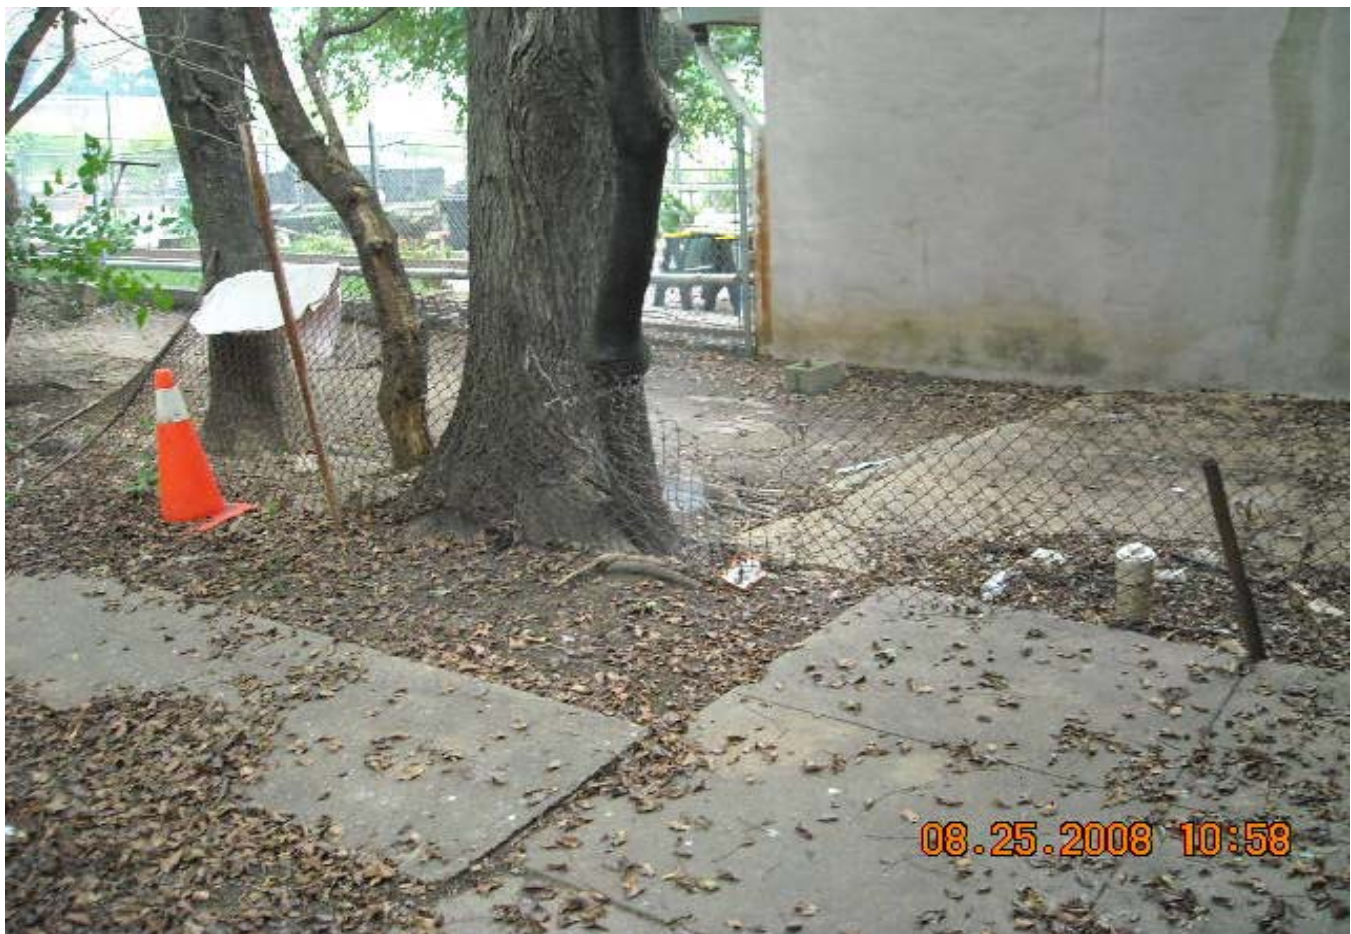
Photograph No: OB04-01
Filename: 1029-552_OB04-01.jpg

Unique Test ID: 552	Date: 08/25/2008	Basin: LL - 44	Manhole ID: S17K__040MH
Defect No: OB04	Supervisor: E.R.	Crew: 03	Dye Test Recommended: N
Location: 2548 FREDERICK RD.			
Source Type: 02 Service Line		Sector: 02 Private	
Location: 08 Yard - Back		Severity: 03 Moderate	Drainage Area: 40
Comments: SMOKE COMING FROM AREA AROUND BASE OF TREE IN CENTER OF PICTURE ON OPPOSITE SIDE OF THE FENCE.

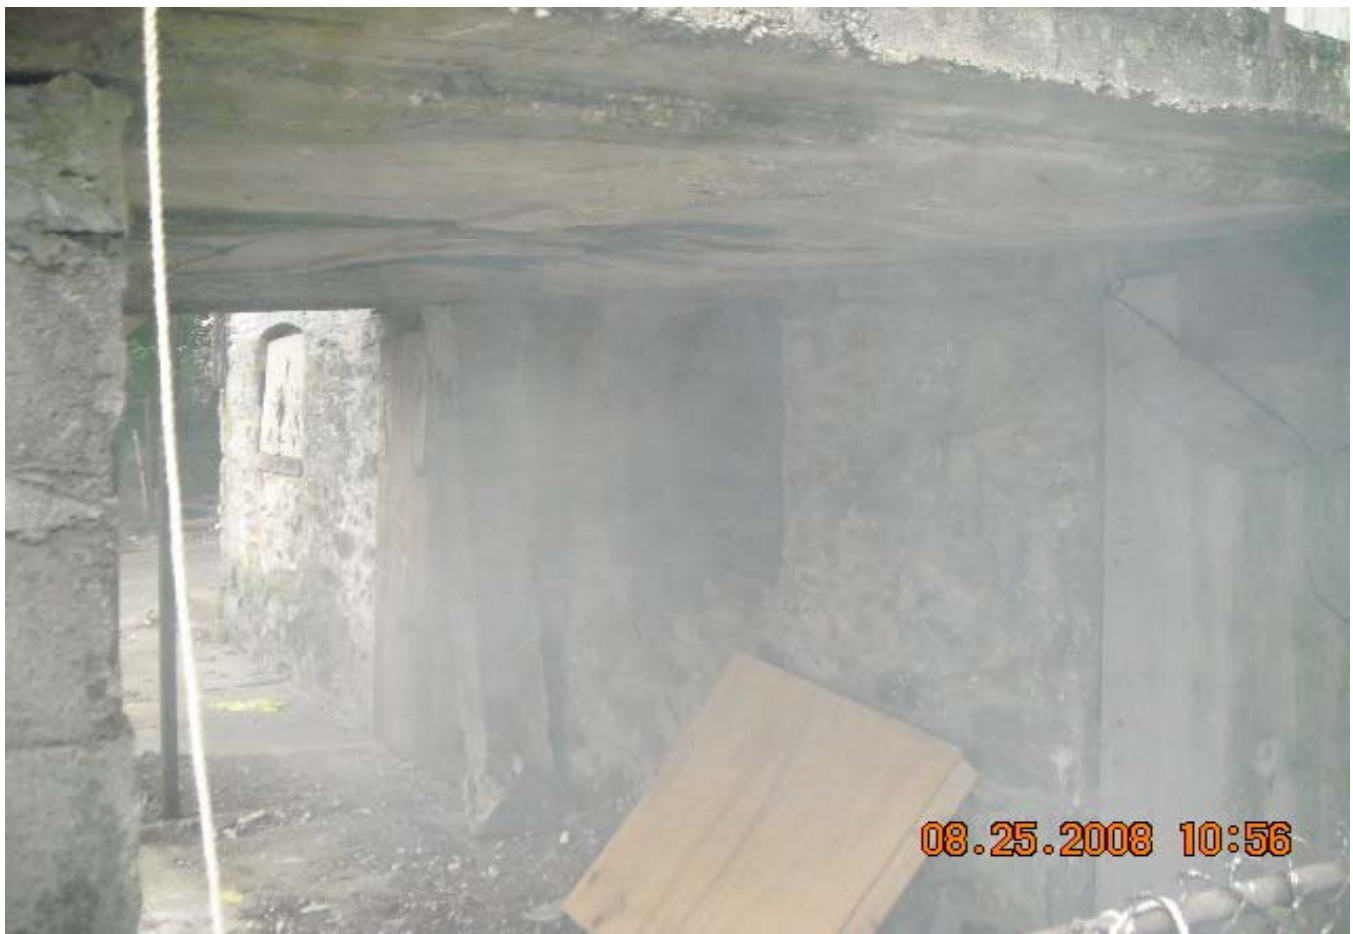
Photograph No: OB05-01
Filename: 1029-552_OB05-01.jpg

Unique Test ID: 552	Date: 08/25/2008	Basin: LL - 44	Manhole ID: S17K__040MH
Defect No: OB05	Supervisor: E.R.	Crew: 03	Dye Test Recommended: N
Location: 319 S. FRANKLINTOWN RD.			
Source Type: 09 Building Interior		Sector: 02 Private	
Location: 14 Other		Severity: 04 Major	
		Drainage Area: 0	
Comments: HEAVY SMOKE COMING FROM INTERIOR OF BUILDING AT 319 S. FRANKLINTOWN RD.

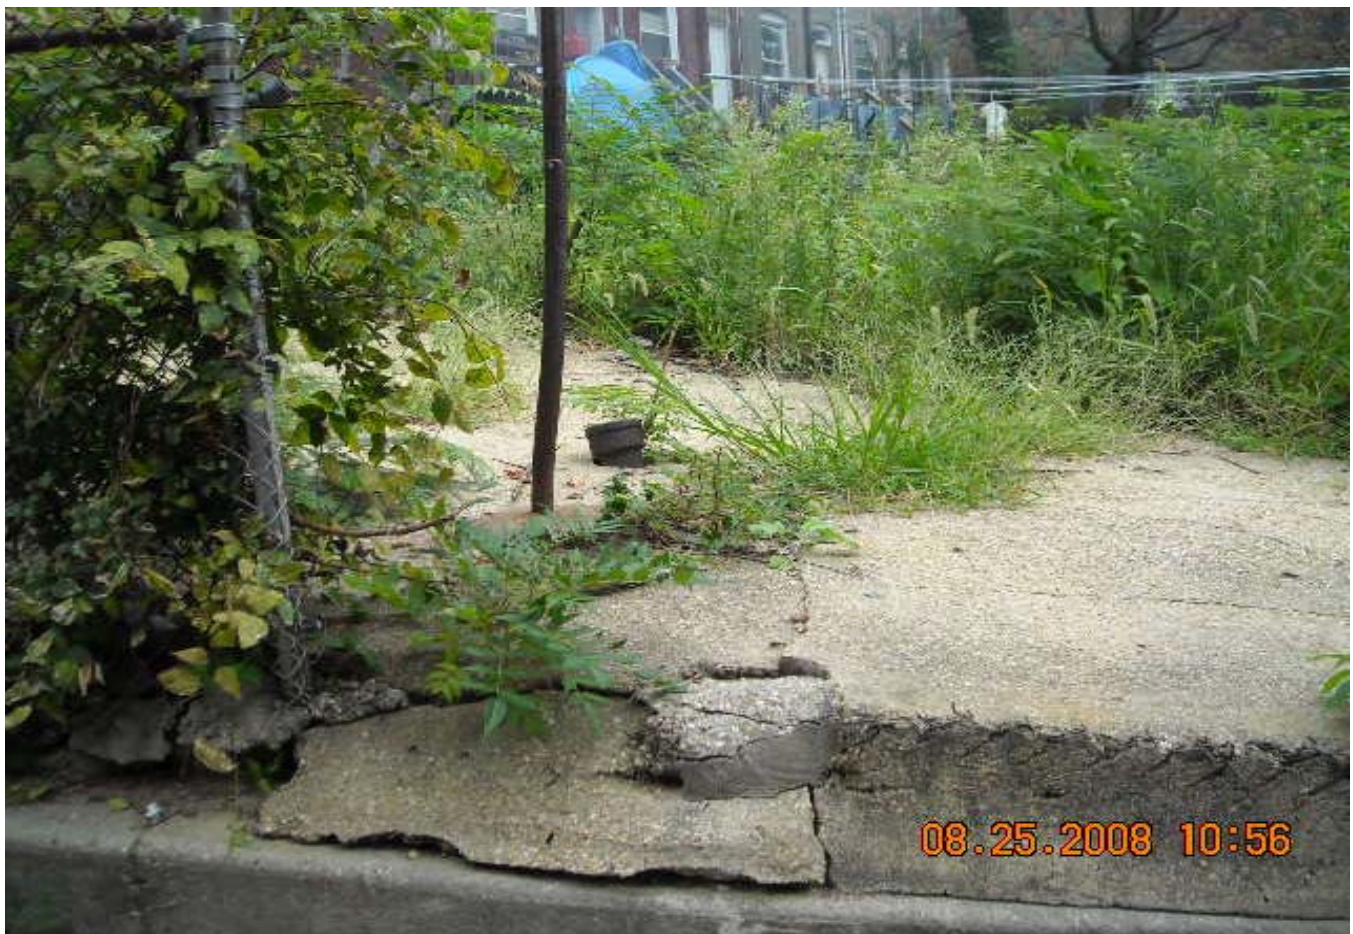
Photograph No: OB06-01
Filename: 1029-552_OB06-01.jpg

Unique Test ID: 552	Date: 08/25/2008	Basin: LL - 44	Manhole ID: S17K__040MH
Defect No: OB06	Supervisor: E.R.	Crew: 03	Dye Test Recommended: N
Location: 321 S. FRANKLINTOWN RD.			
Source Type: 02 Service Line		Sector: 02 Private	
Location: 06 Curb		Severity: 03 Moderate	Drainage Area: 50
Comments: SMOKE COMING FROM CURB ALONG ALLEY BEHIND PROPERTY.
